A report on the pre-construction stage geological investigations of Jamrani dam project, river Gola district Nainital, U.P. (with eight photos) by Vinod K. Sharma, A.S.E. (August 1990)

GEOLOGICAL SURVEY OF INDIA  
NORTHERN REGION  
ENGINEERING GEOLOGY DIVISION-3

A REPORT ON THE PRE-CONSTRUCTION STAGE GEOLOGICAL  
INVESTIGATIONS OF JAMRANI DAM PROJECT, RIVER GOLA,  
DISTRICT NAINITAL, U.P.

Vinod K. Sharma  
Geological Survey of India  
(Aug 1990)

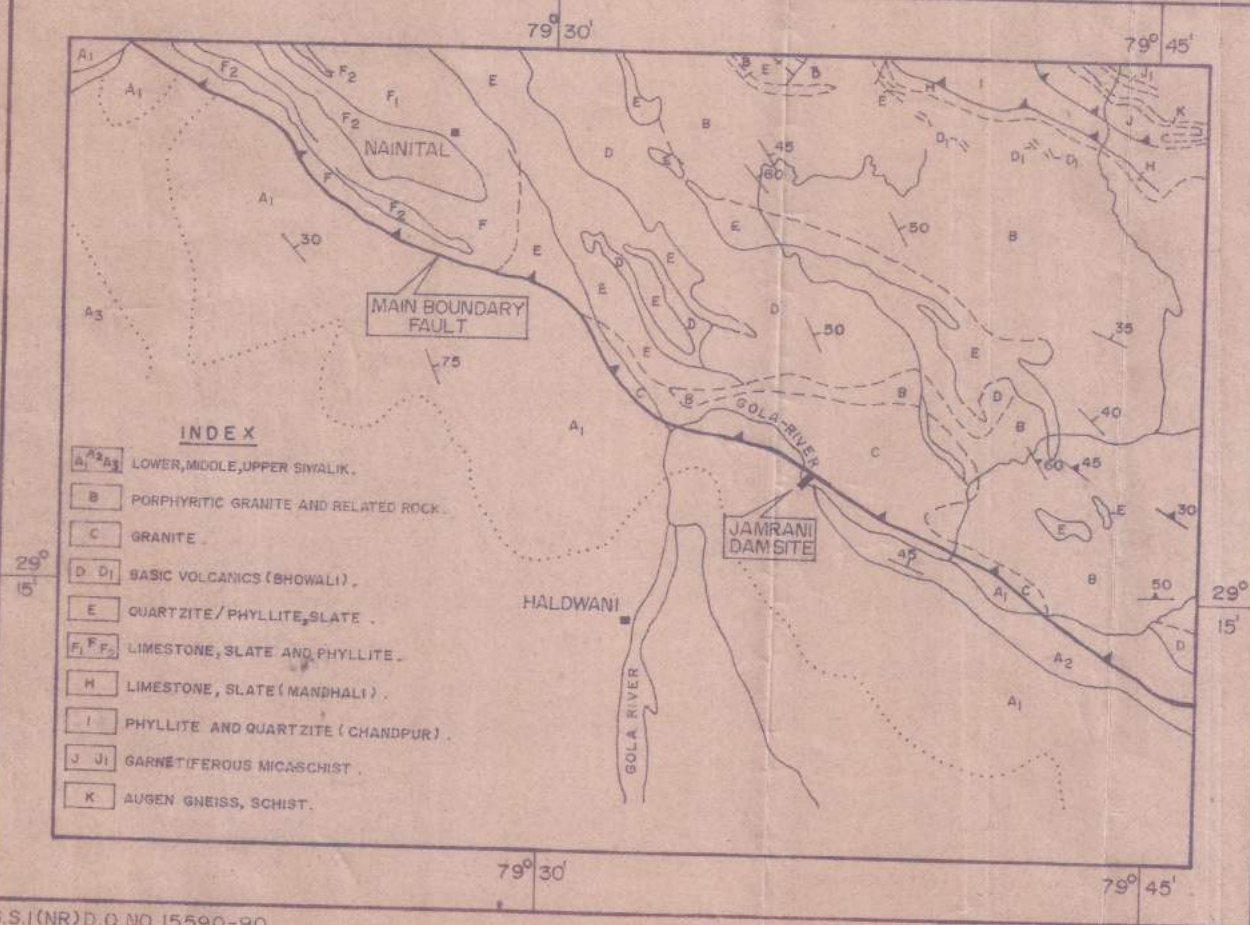
# JAMRANI DAM PROJECT GEOLOGICAL MAP OF MAIN BOUNDARY FAULT ZONE (NEAR AMRITPUR, DISTRICT, NAINITAL)

10. The general trend of the Siwalik rocks near the Fault is  $N75^{\circ}E-S75^{\circ}W$  and they dip about  $75^{\circ}$  towards NW. The Siwalik sandstone, exposed near the thrust zone is mainly medium to coarse-grained, having accessory mineral assemblage of muscovite, garnet, tourmaline and biotite, showing preferred orientation parallel to bedding. Various sedimentary structures, such as current bedding, graded bedding are at places, displaced by a set of minor faults transverse to the MBF. These faults trend mainly in  $N20^{\circ}-30^{\circ}E$  direction and dip  $60^{\circ}-80^{\circ}$  towards NE. The Lower Siwalik rocks at the location are followed by a zone of sheared quartzite (with manifestations of iron leaching in about 10-15m wide zone), lenses of quartzite (vein quartz) within highly pulverised schists phyllite, basic rocks (?) and granite. In the area covered by the mapping the following sequence of lithounits is encountered (Plate-II).

Amritpur Granite	Coarse-grained granite, Amphibolite(?) purple schist/ phyllite.
Main Boundary Fault Zone	Sheared quartzite   20-30m siltstone/clayshale
Lower Siwalik Formation	Sandstone with elongated grains, claystone Medium-grained sandstone Clayshale (Chocolate/Red-coloured) Coarse-grained sandstone

11. The thrust zone of 20-30m width is manifested by shearing, elongation of mineral grains in Siwalik, pulverised schist/phyllite and development of stretched lenses of vein quartz of Amritpur granite. Rock samples from within the Fault zone area, collected to study the microscopic features had been forwarded to the Petrology Division, GSI, N. Lucknow and the results are still awaited.

31. A few workers have reported neotectonic activity along the Main Boundary Fault, farther towards west of the dam area. It is recommended that geodetic precision levelling across the trace of the MBF may be initiated in the area so that the activity, if any, could be monitored.

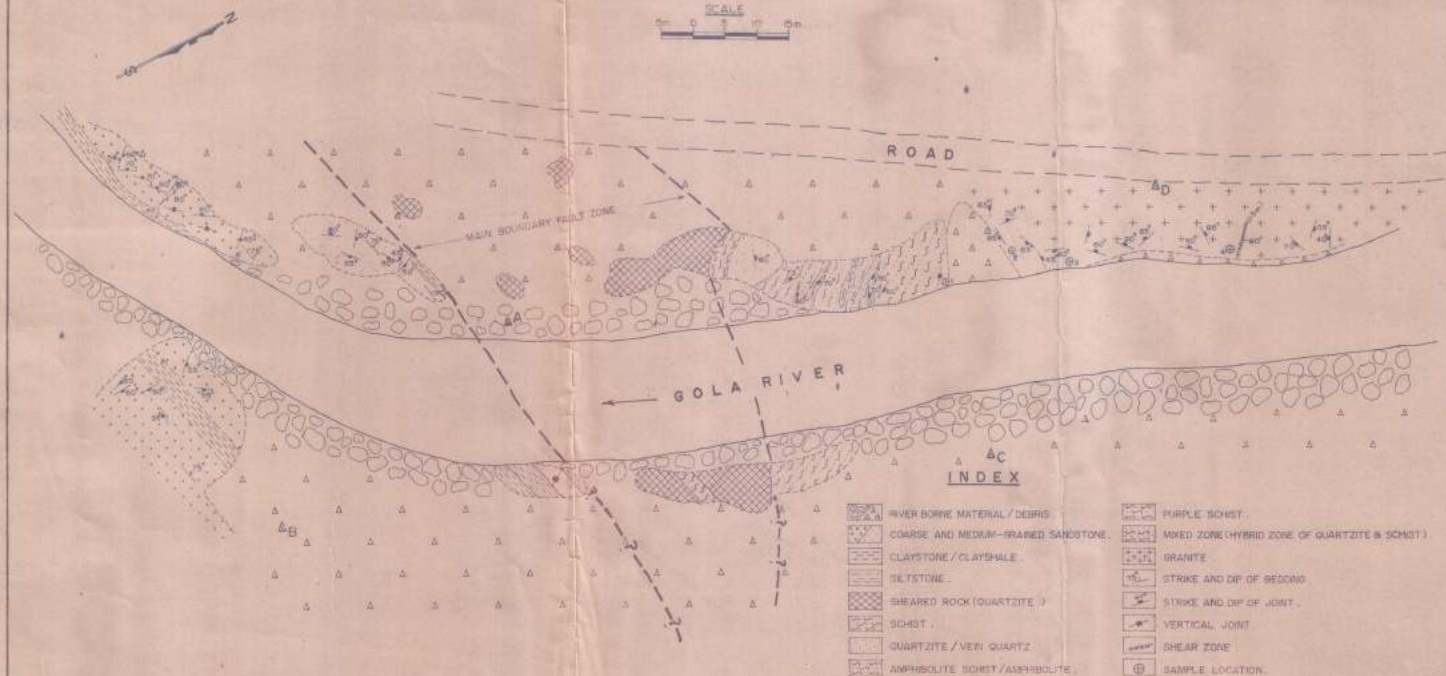
# JAMRANI DAM PROJECT GEOLOGICAL MAP OF THE DAM SITE

12. The dam site is located on the lower Siwalik rocks of the outer Himalaya, which are separated from the lesser Himalayan rocks, farther towards North by the Main Boundary Fault. Detailed geological mapping of the dam site area, on 1:1000 scale was carried out initially by Shri H.M. L. during the field season 1976-77 and subsequently by Shri K. Anbalagan during 1981-84 and 1985-86 (Plate-III). The mapping has revealed that the dam site area is occupied by an alternate sequence of sandstone, siltstone and clayshale. The sandstone is generally grey to brown in colour, micaceous, fine to coarse-grained and occasionally friable due to poor cementation and sometimes calcareous. The clayshale exposed at the site is grey, brown and purple in colour and is generally weathered near the surface with many shrinkage cracks. The bands of micaceous siltstone are generally dark grey, moderately hard and well cemented. The rocks exposed at the dam site generally strike NW-SE with dip of  $30^{\circ}$ - $50^{\circ}$  in north-east direction, i.e., upstream.

13. The rock exposures on the right bank at the dam site are more abundant than on the left bank which is largely covered by debris/thick vegetation with very scant outcrops. The continuity of bands of sandstone, siltstone and clayshale from one bank of the river to the other is not visible. In order to determine whether or not the bands of sandstone, siltstone and clayshale exposed on the right bank (Plate-III) match with those exposed on the left bank, theoretical traces of some selected clayshale bands A, B, C and D (Plate-III) were drawn and projected on the left bank. The projected trace of clayshale band 'A' fell on the slide debris and hence could not be correlated. The trace of band 'B' exposed on the right bank nearly corresponded to the clayshale band exposed in a gully section on the left bank. Similarly, the trace of the band 'C' also correspond to one clayshale band exposed on the left bank. Hence, the continuity of the rock bands is more

or less established, which points out that there is no lateral displacement of the bands along the course of river. Though, quite a few such bands could be traced/correlated on either banks but, due to lateral facies variations in the rocks, some other bands of claystone and siltstones tend to attenuate and could not be traced/correlated on the other bank. In order to determine the mineral constituents present in various claystone bands exposed at the dam site, the X-ray and Differential Thermal Analysis (D.T.A.) were carried out on ten samples of clayshales. The objective of the analysis was to ascertain whether or not expansive clays (such as montmorillonite) which because of their swelling properties, under saturation, are harmful are present in the clayshale bands. The samples from the clayshale bands (plate-III) were collected and the analysis was made by the Mineral Physics Division, Northern Region, Geological Survey of India, Lucknow. The results of the tests indicate presence of montmorillonite in three bands (II, III and IV) of claystone/clayshale. However, the mineral occurs only in trace amount and its presence in the dam foundation may not be significant. The complete report of the X-ray and D.T.A. is furnished in appendices III and IV of this report.
